Re: Agee Farms, LLC – Compliance Evaluation Inspection
Permit Tracking No. SOPC00232
81 Hopewell Road Dyer, Gibson County, Tennessee 38330

ICIS NPDES Facilities Inspection Report

Compliance Inspection for Concentrated Animal Feeding Operation (CAFO)

PHOTOLOG

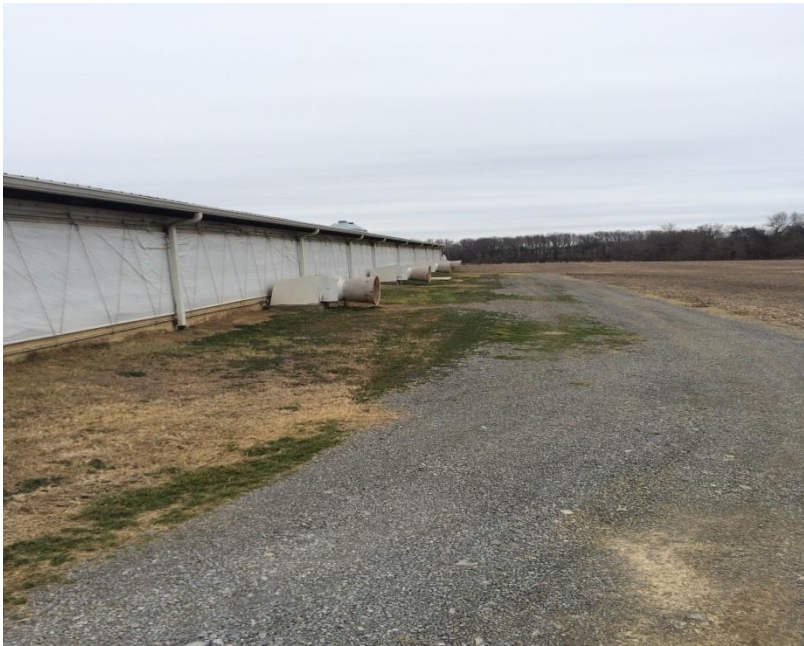
Picture 6

Date of Photo: 1/19/16. Photo taken by: Kevin Smith. Location/Site Name: Agee Farms/SOPC00232. TDWR personnel Present: Kevin Smith. Remarks: Picture is of eastern side of eastern pit barn. Notice gutters installed on pit barn. There was good vegetation between pit barn and gravel drive used to access compost shed. Picture was taken standing on southeast side of eastern pit barn facing north.

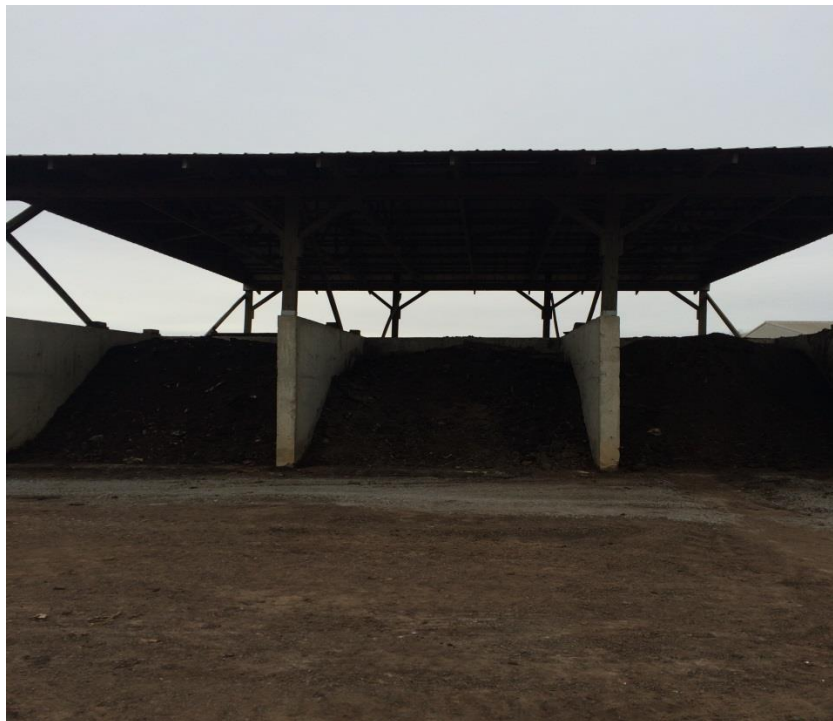
Picture 7

Date of Photo: 1/19/16. Photo taken by: Kevin Smith. Location/Site Name: Agee Farms/SOPC00232. TDWR personnel Present: Kevin Smith. Remarks: Picture is of compost shed. Picture was taken standing on east side of compost shed facing west. There are 3 compost bays on this side of covered compost shed. Cotton gin waste is used as the bulking agent for the compost bays.

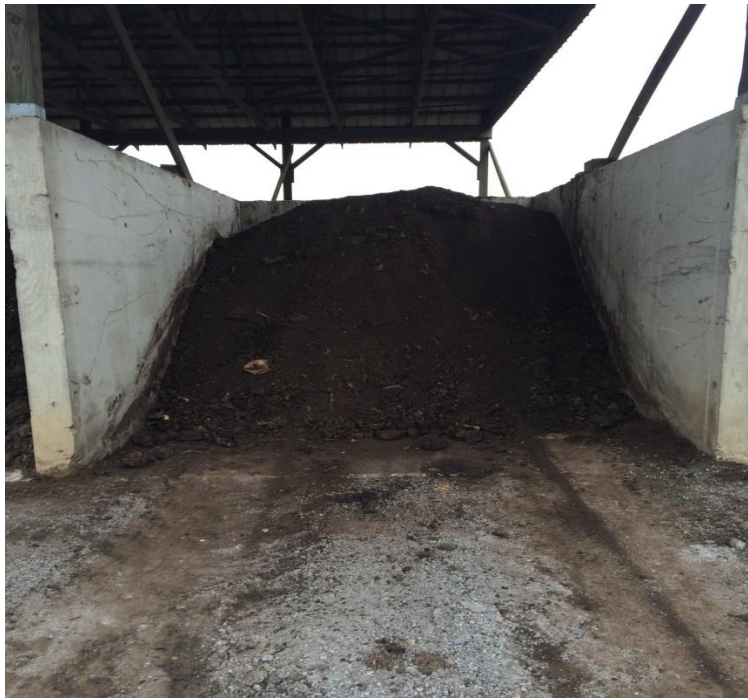
Picture 8

Date of Photo: 1/19/16. Photo taken by: Kevin Smith. Location/Site Name: Agee Farms/SOPC00232. TDWR personnel Present: Kevin Smith. Remarks: Picture is of the northernmost compost bay located on east side of compost shed. No leachate or uncovered hog remains were observed on day of inspection. Picture was taken standing on east side of compost shed facing west.

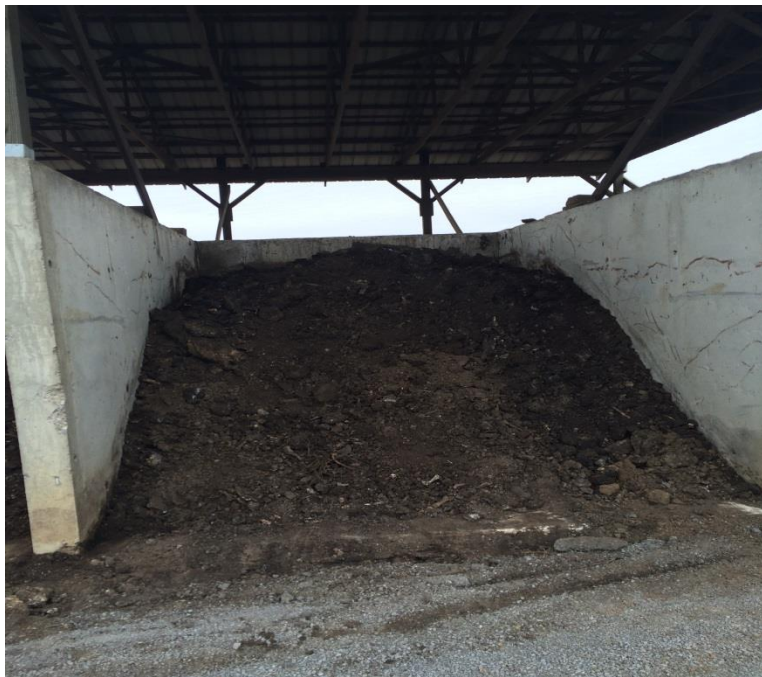
Picture 9

Date of Photo: 1/19/16. Photo taken by: Kevin Smith. Location/Site Name: Agee Farms/SOPC00232. TDWR personnel Present: Kevin Smith. Remarks: Picture is of the middle compost bay located on east side of compost shed. No leachate or uncovered hog remains were observed on day of inspection. Picture was taken standing on east side of compost shed facing west.

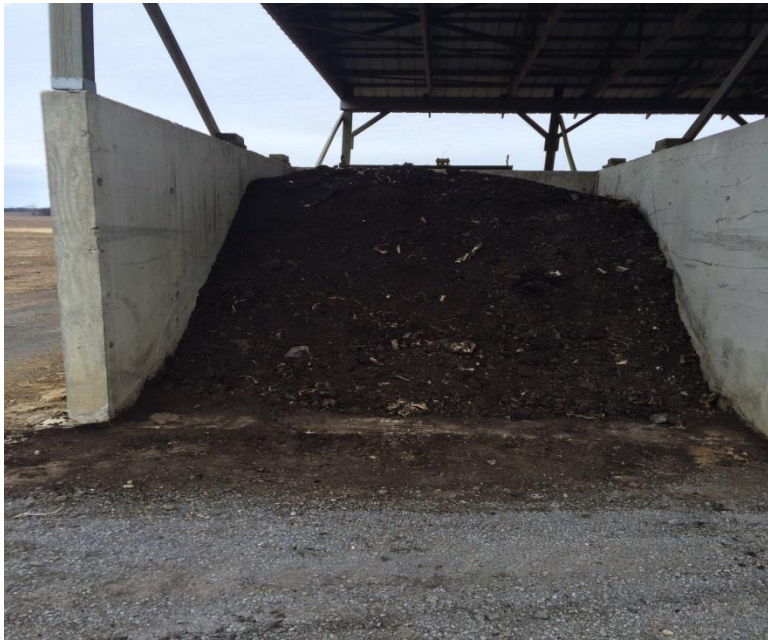
Picture 10

Date of Photo: 1/19/16. Photo taken by: Kevin Smith. Location/Site Name: Agee Farms/SOPC00232. TDWR personnel Present: Kevin Smith. Remarks: Picture is of the southernmost compost bay located on east side of compost shed. No leachate or uncovered hog remains were observed on day of inspection. Picture was taken standing on east side of compost shed facing west.

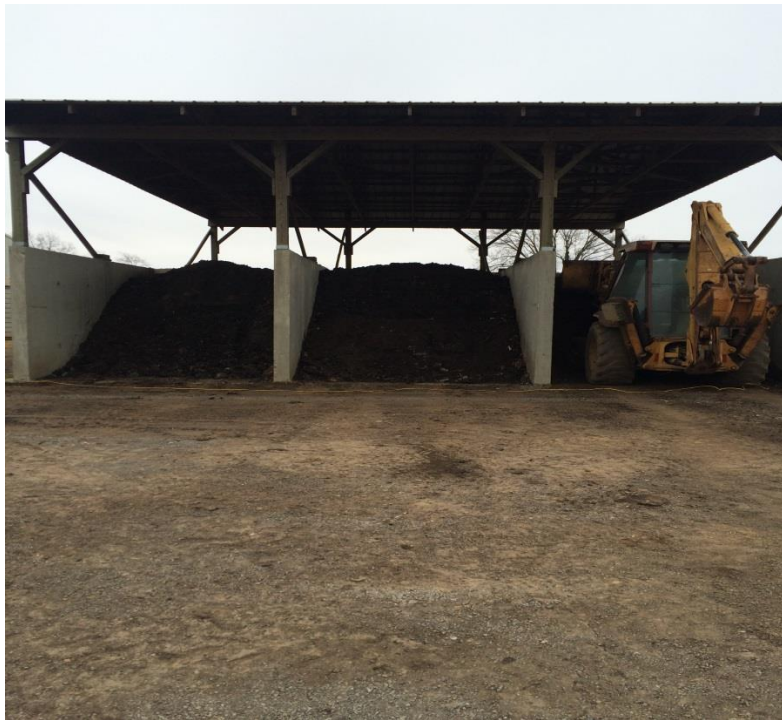
Picture 11

Date of Photo: 1/19/16. Photo taken by: Kevin Smith. Location/Site Name: Agee Farms/SOPC00232. TDWR personnel Present: Kevin Smith. Remarks: Picture is of compost shed. Picture was taken standing on west side of compost shed facing east. There are 3 compost bays on this side of covered compost shed. A backhoe was parked in the southernmost compost bay on the west side of compost shed on day of inspection.

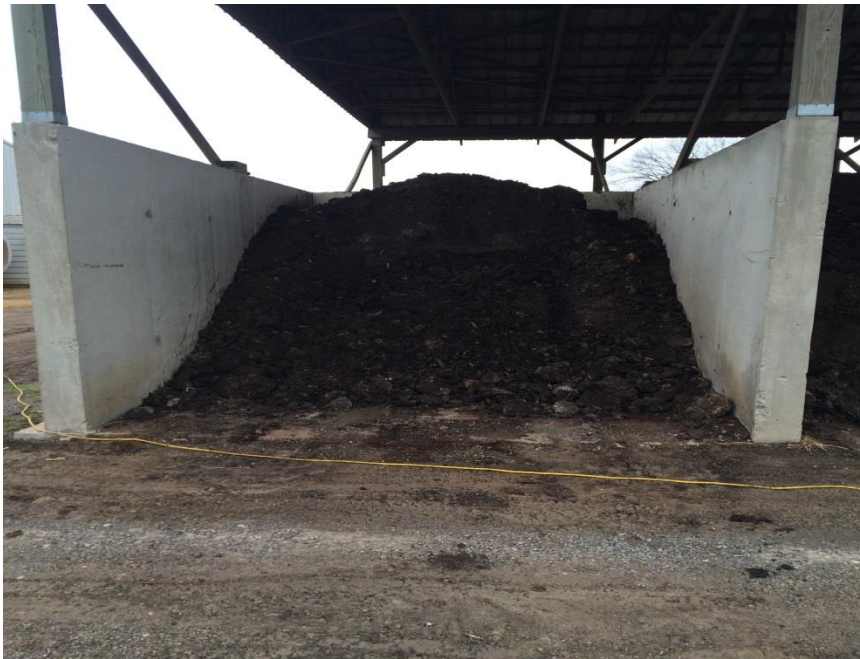
Picture 12

Date of Photo: 1/19/16. Photo taken by: Kevin Smith. Location/Site Name: Agee Farms/SOPC00232. TDWR personnel Present: Kevin Smith. Remarks: Picture is of northern most compost bay on west side of compost shed. No leachate or uncovered hog remains were observed on day of inspection. Picture was taken standing on west side of compost shed facing east.

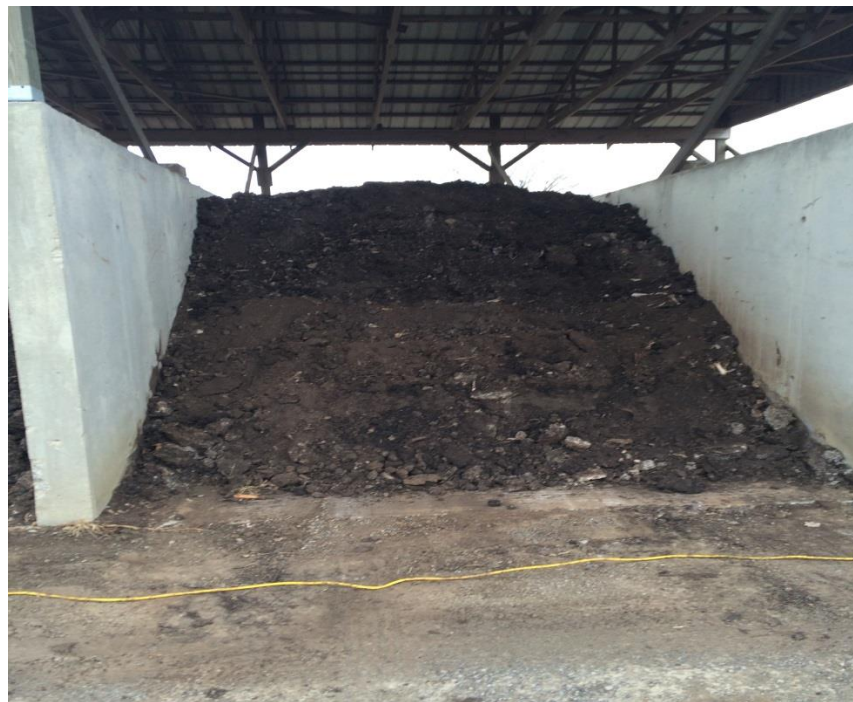
Picture 13

Date of Photo: 1/19/16. Photo taken by: Kevin Smith. Location/Site Name: Agee Farms/SOPC00232. TDWR personnel Present: Kevin Smith. Remarks: Picture is of the middle compost bay located on west side of compost shed. No leachate or uncovered hog remains were observed on day of inspection. Picture was taken standing on west side of compost shed facing east.

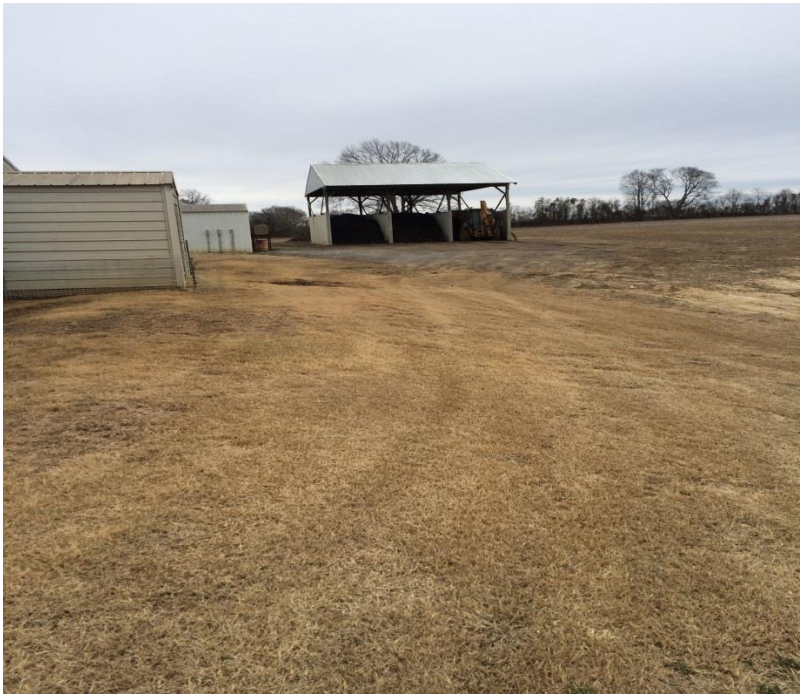
Picture 14

Date of Photo: 1/19/16. Photo taken by: Kevin Smith. Location/Site Name: Agee Farms/SOPC00232. TDWR personnel Present: Kevin Smith. Remarks: Picture was taken standing at southwest corner of western pit barn facing east/southeast. There was good vegetation observed on southern slope behind pit barns.

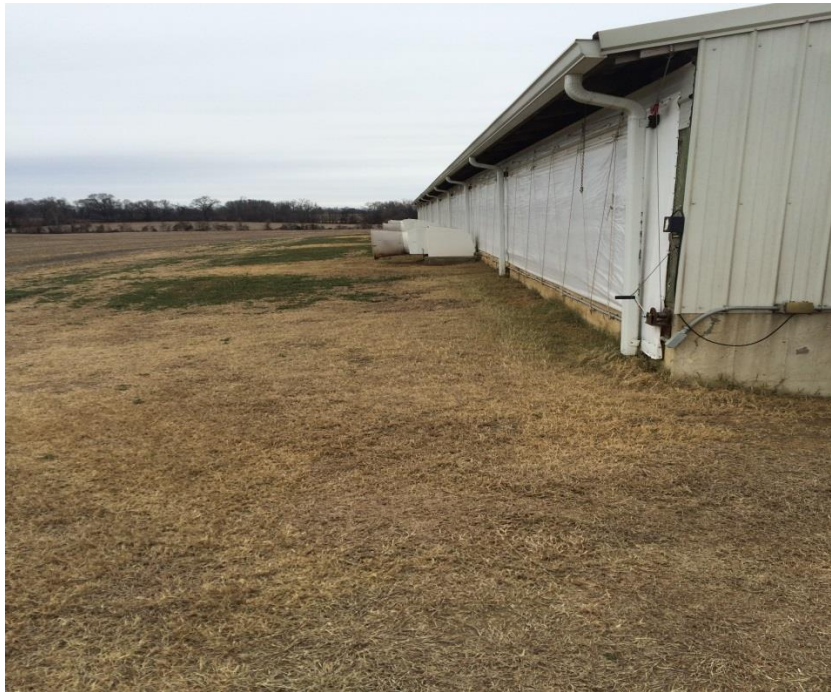
Picture 15

Date of Photo: 1/19/16. Photo taken by: Kevin Smith. Location/Site Name: Agee Farms/SOPC00232. TDWR personnel Present: Kevin Smith. Remarks: Picture is of western side of western most pit barn. The western slope had good vegetation. Notice gutters on pit barn. Picture was taken standing at southwest corner of western pit barn facing north.

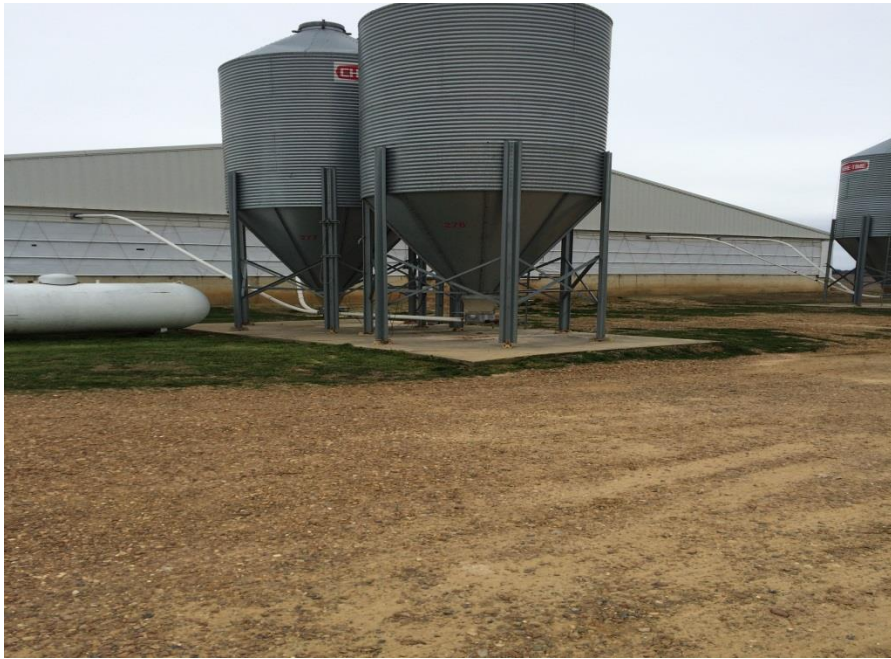
Picture 16

Date of Photo: 1/19/16. Photo taken by: Kevin Smith. Location/Site Name: Agee Farms/SOPC00232. TDWR personnel Present: Kevin Smith. Remarks: Picture is of north side of western most pit barn. Picture was taken standing on north side of western most pit barn facing south/southwest.

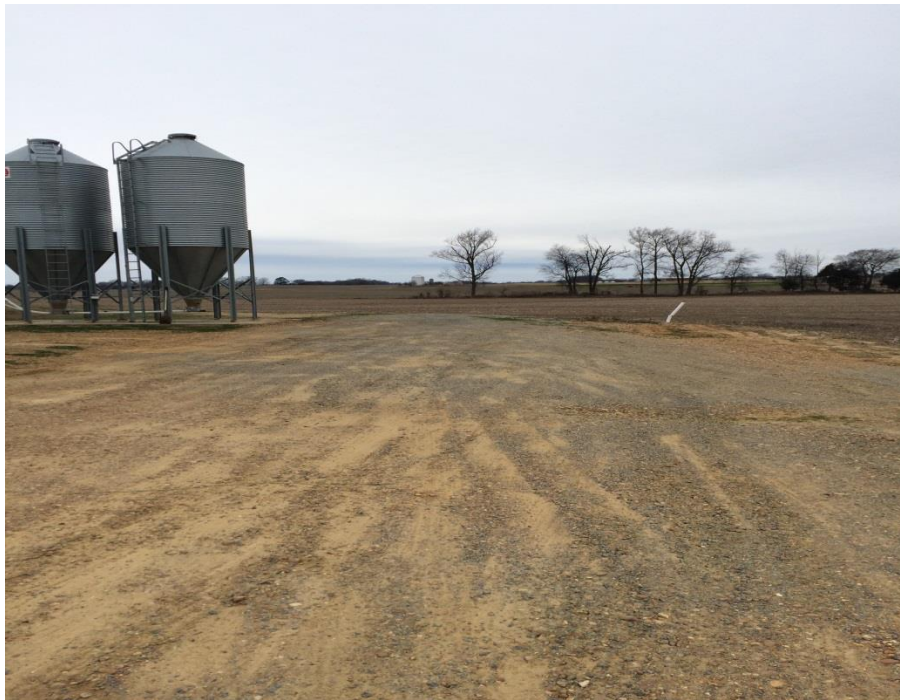
Picture 17

Date of Photo: 1/19/16. Photo taken by: Kevin Smith. Location/Site Name: Agee Farms/SOPC00232. TDWR personnel Present: Kevin Smith. Remarks: Picture is of graveled area located on north of western most pit barn. The white stake in picture is where one of the master drains for the gutters on pit barns outlets.

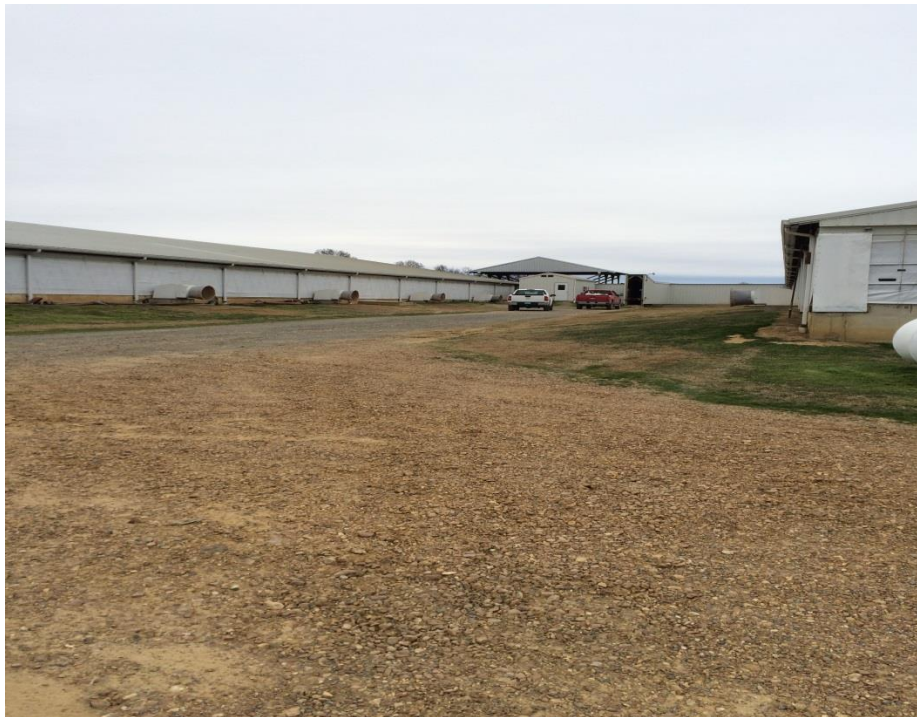
Picture 18

Date of Photo: 1/19/16. Photo taken by: Kevin Smith. Location/Site Name: Agee Farms/SOPC00232. TDWR personnel Present: Kevin Smith. Remarks: Picture is of alley way between the eastern and west pit barns.

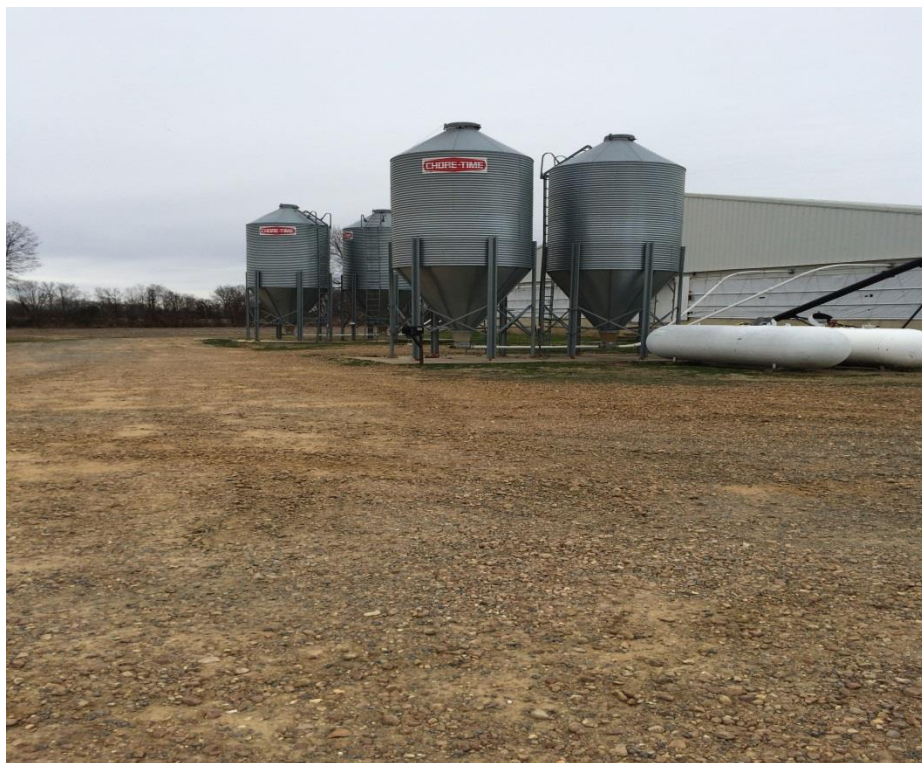
Picture 19

Date of Photo: 1/19/16. Photo taken by: Kevin Smith. Location/Site Name: Agee Farms/SOPC00232. TDWR personnel Present: Kevin Smith. Remarks: Picture is of area north of the eastern most pit barn.

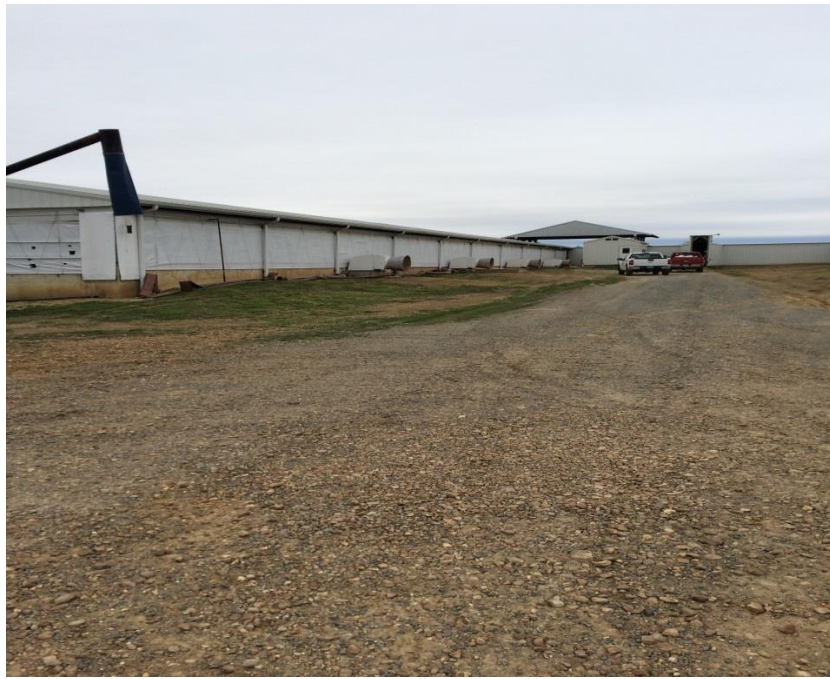
Picture 20

Date of Photo: 1/19/16. Photo taken by: Kevin Smith. Location/Site Name: Agee Farms/SOPC00232. TDWR personnel Present: Kevin Smith. Remarks: Picture is of west side of eastern most pit barn. Notice gutter down spouts. The gutter down spouts are all tied into a master drain which outlets rainwater to an area north of the pit barns.

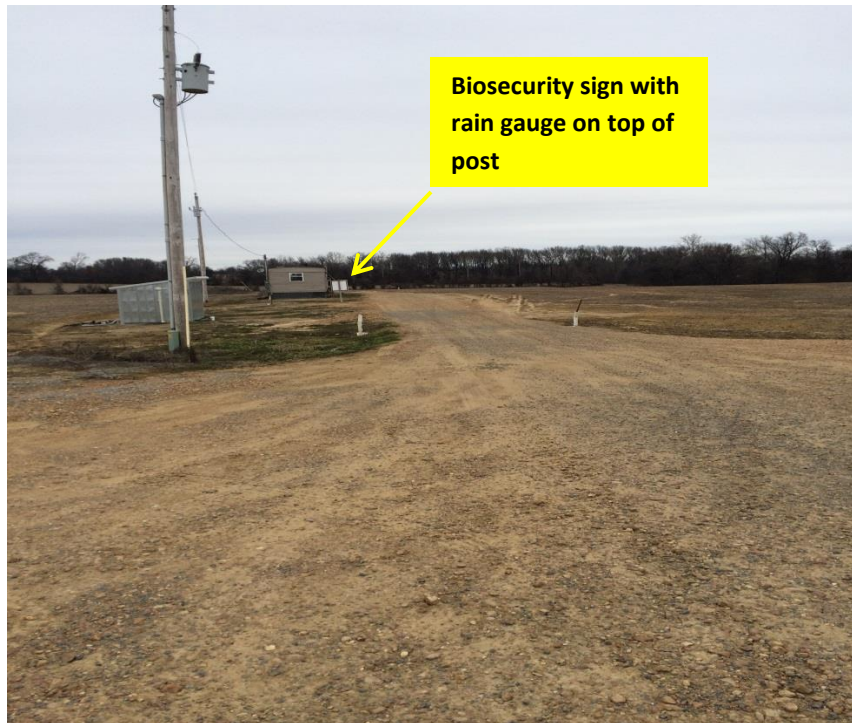
Picture 21

Date of Photo: 1/19/16. Photo taken by: Kevin Smith. Location/Site Name: Agee Farms/SOPC00232. TDWR personnel Present: Kevin Smith. Remarks: Picture is of drive entrance from Hopewell road. Picture was taken standing on north side of pit barns facing north towards Hopewell Road.

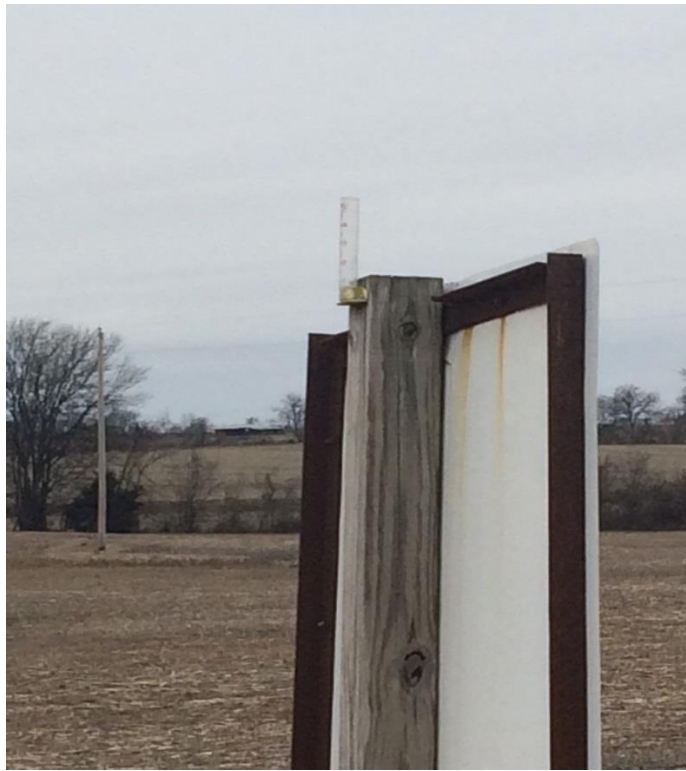
Picture 22

Date of Photo: 1/19/16. Photo taken by: Kevin Smith. Location/Site Name: Agee Farms/SOPC00232. TDWR personnel Present: Kevin Smith. Remarks: Picture is of rain gauge located on biosecurity sign which is located on west side of drive entrance to the facility.
